The Landslide Dam Breach Impact Assessment - A Case Study of the Hokkaido Earthquake in Japan

Chia-Hsing Lin (林家興), Chen-Yu Wu(吳振佑), Kuo-Wei Chen(陳國威), Chen-Yu Chen(陳振宇)
Soil and Water Conservation Bureau, Taiwan (台灣水土保持局)

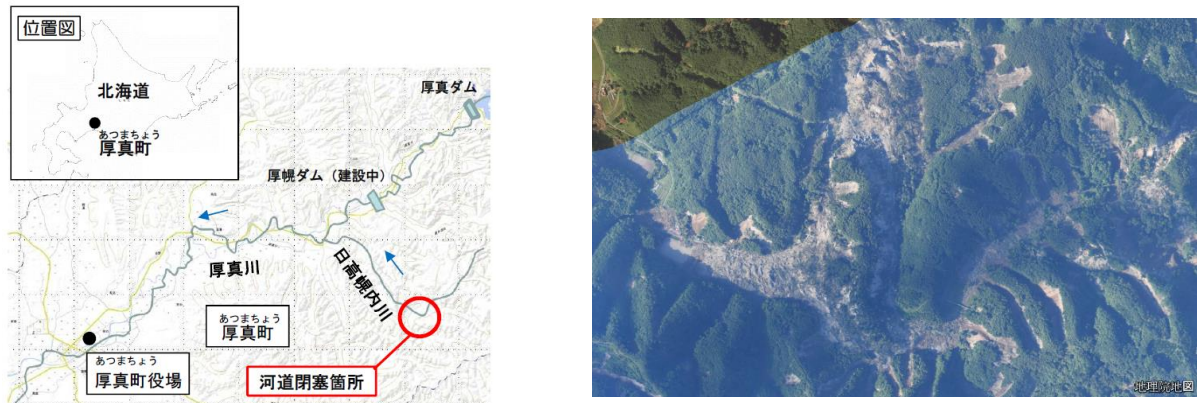
Fig. 1 Location of large-scale landslide at Atsuma Town, Hokkaido, Japan (Geospatial Information Authority of Japan Website).

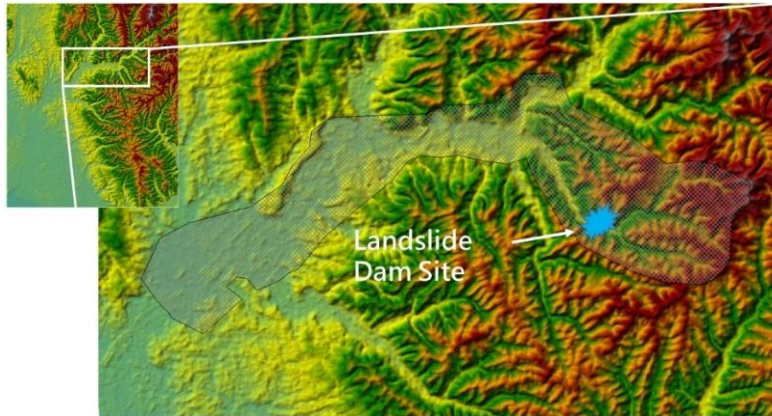
Fig. 2 Study map of the natural dam location and simulation domain

The simulation has been made for unsteady flow routing for 2 days duration. Based on the GDEM V2 terrain model data, the simulation domain could be identified as **Fig. 2**. The parameters used in the model were listed in **Table 1**, and the mesh size is 50 x 50 m, dam height is 50m, and with different breach formation time (0.5 to 6 hours). The hydrograph of the discharge could be estimated by the rational formula and imposed as the upstream boundary condition for overtopping failure breach analysis. The estimated elevation-volume curve of the barrier lake (**Fig. 3**) is also imposed at the upstream boundary of the computational domain for this dam breach simulation.

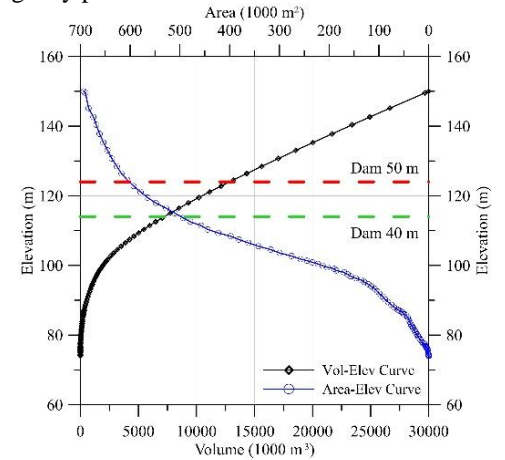
Fig. 3 The estimated elevation-area-volume curve of impounded lake

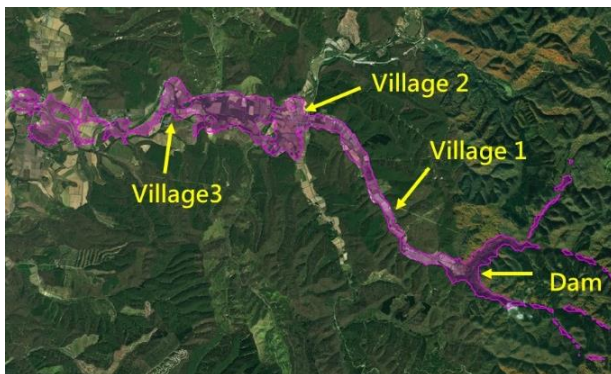
Fig. 4 Inundated area of dam break in Atsuma river

The results of the flood map indicate that flooding and rapidly flow is observed in the downstream area. The flood wave arrival time result showed the short breach formation time was earlier than that of the long breach formation time. The simulation using short breach formation time showed that flow depth, velocity, and inundated area much larger, and a flood wave arrival time earlier 2 to 8 times, than that modeled by the longer breach formation time cases (**Table 2**).
