# Apply Smartphone apps to real time 3D Modeling of Sediment-Related Disasters

Agency of Rural Development and Soil & Water Conservation, Taiwan (台灣農村發展及水土保持署)

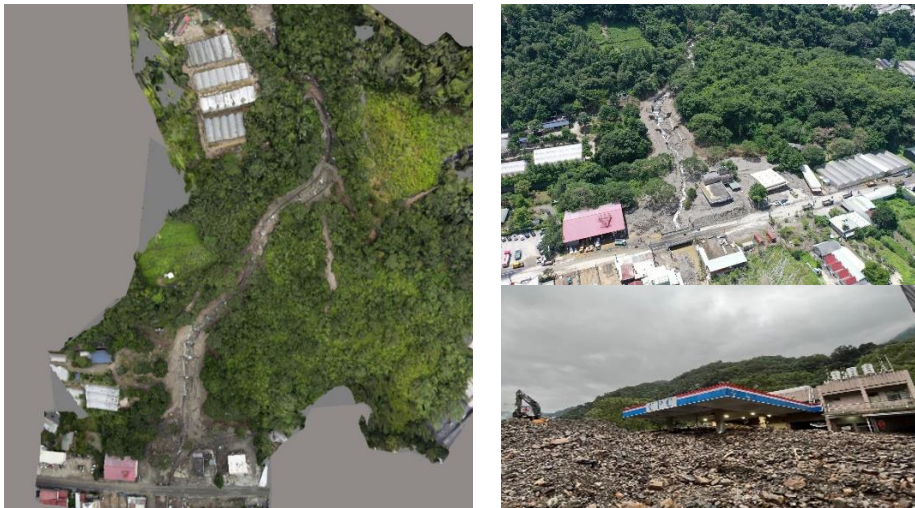
**Fig. 1** Debris-flow torrent (DF013) and Gas station

The case study presented in this research occurred at 3:00 PM on August 4, 2023, at Nanfeng Village, Ren'ai Township, Nantou County, Taiwan (**Fig. 1**, WGS84: 24.003126,121.086072). The site is located within the debris-flow torrent (DF013). Triggered by Typhoon Kanu, which brought significant rainfall from the southwest monsoon, a debris flow ensued. The flow eroded the rear tributary's banks on both sides, ultimately burying a gas station.

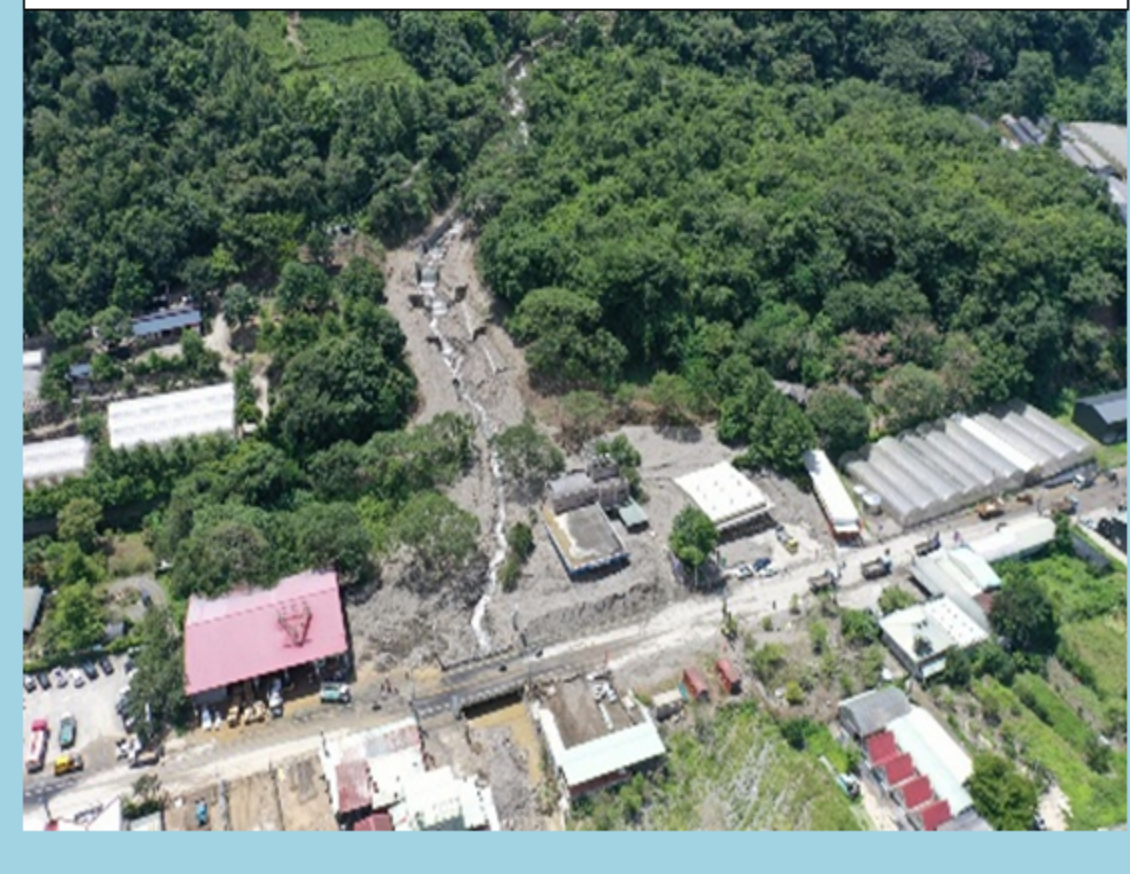
**Site condition**  
**Debris-flow torrent (DF013)**  
1. **Type of disaster** : Debris flow  
2. **Occurrence date** : 2023-08-04  
3. **Location** : Nanfeng Village, Ren'ai Township, Nantou County, Taiwan  
4. **Coordinate** : 24.003126, 121.086072 (WGS84)  
5. **Investigation date**: 2023-08-14(After disaster)  
2024-04-09(8 months later)

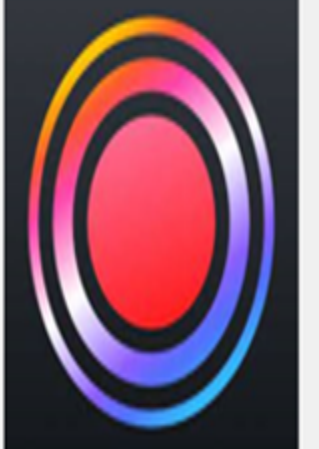
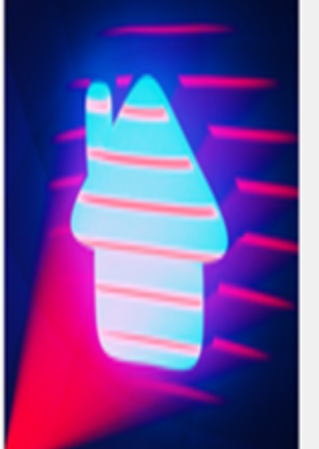
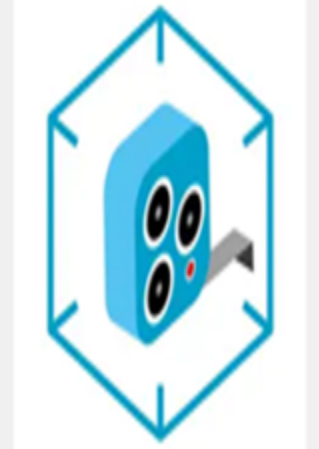
| Item | | | |
| Application | Scaniverse | 3d Scanner App | ConstLiDAR Lite |

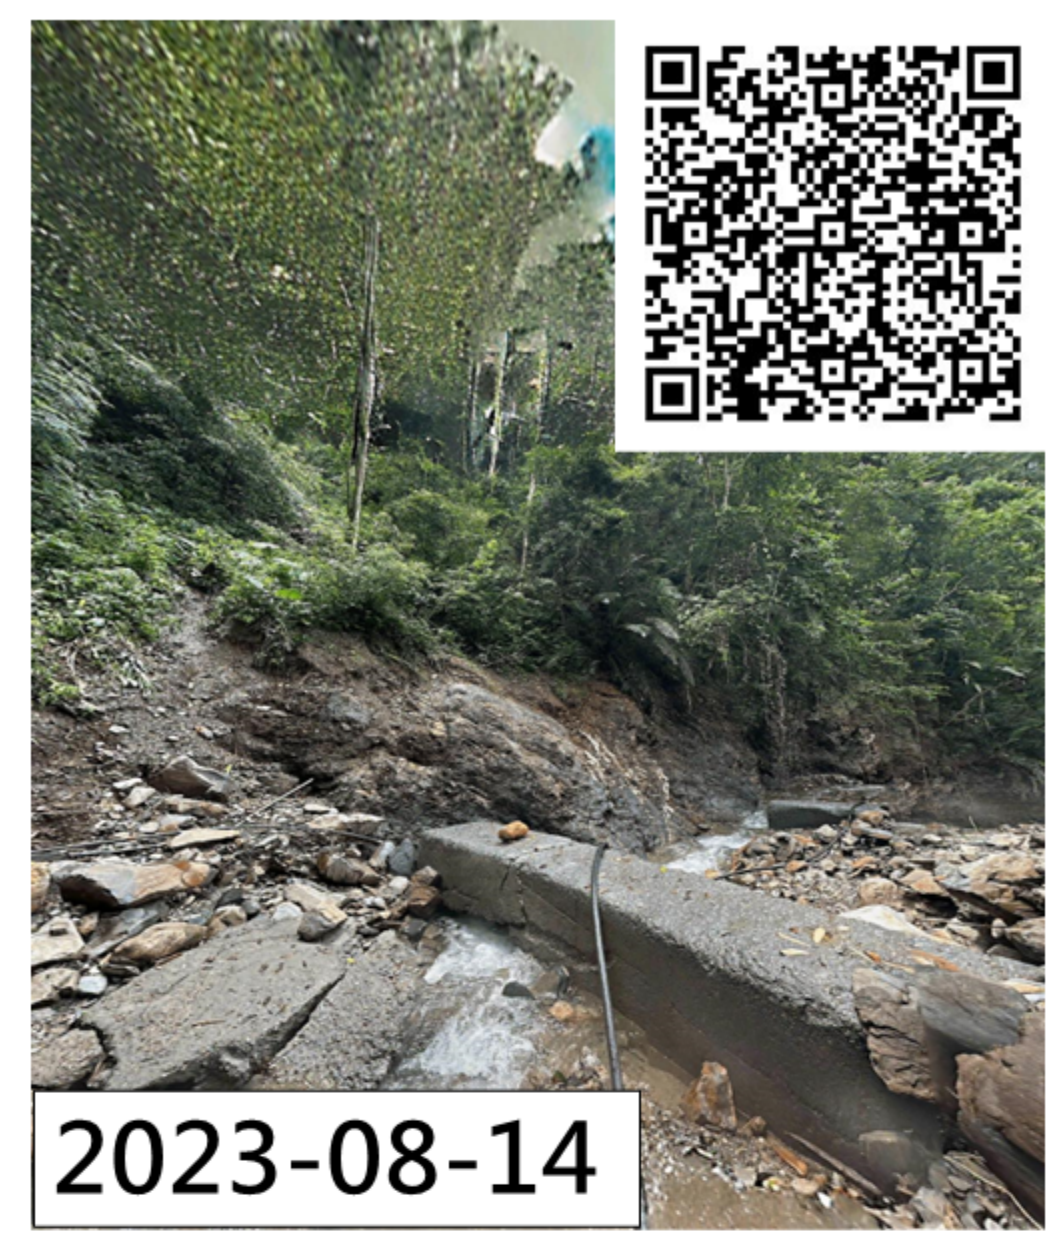
**The 360-degree panoramic and 3D model in stream**  
**(1) 360-degree Panorama**

2023-08-14  
After the debris flow, vegetation still densely covers this area.

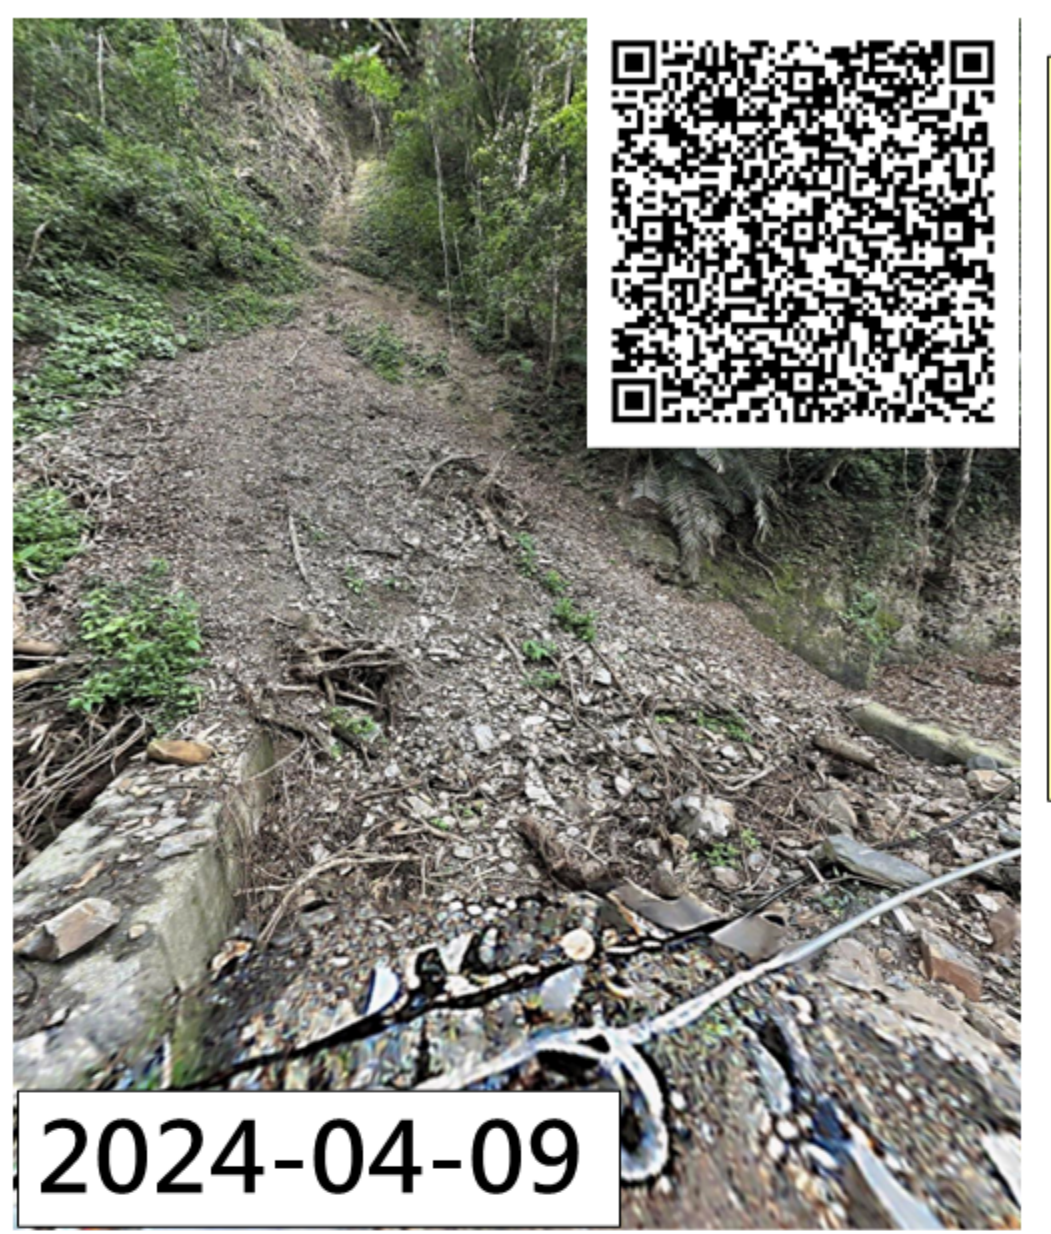
2024-04-09  
After 8 months, the continuous outflow of debris and sediment persists.

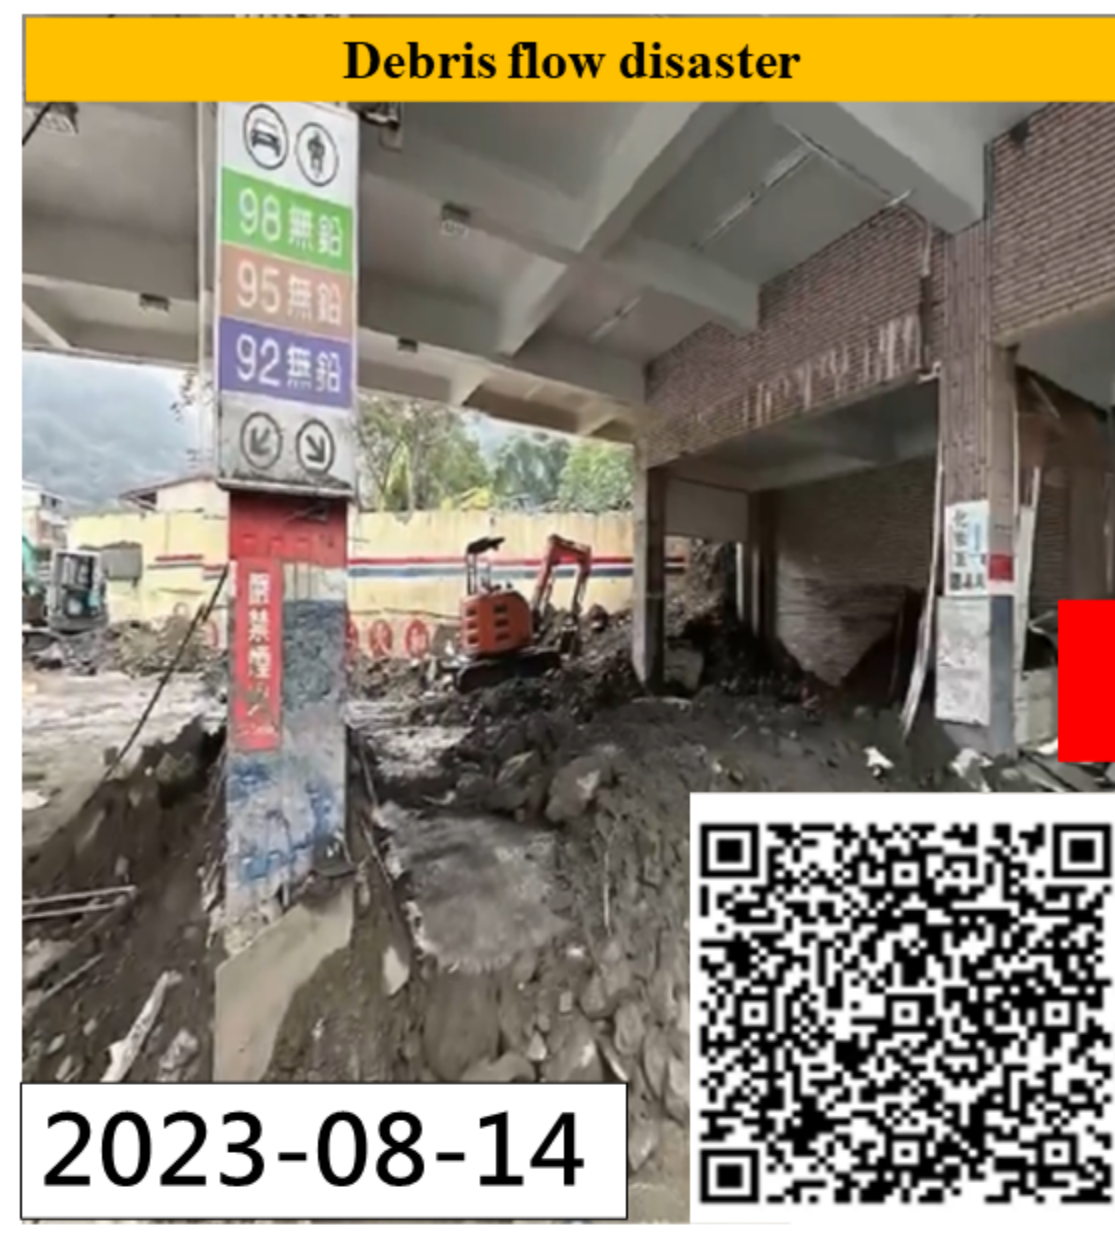
**The 360-degree panoramic and 3D model in gas station**

2023-08-14  
Debris flow disaster

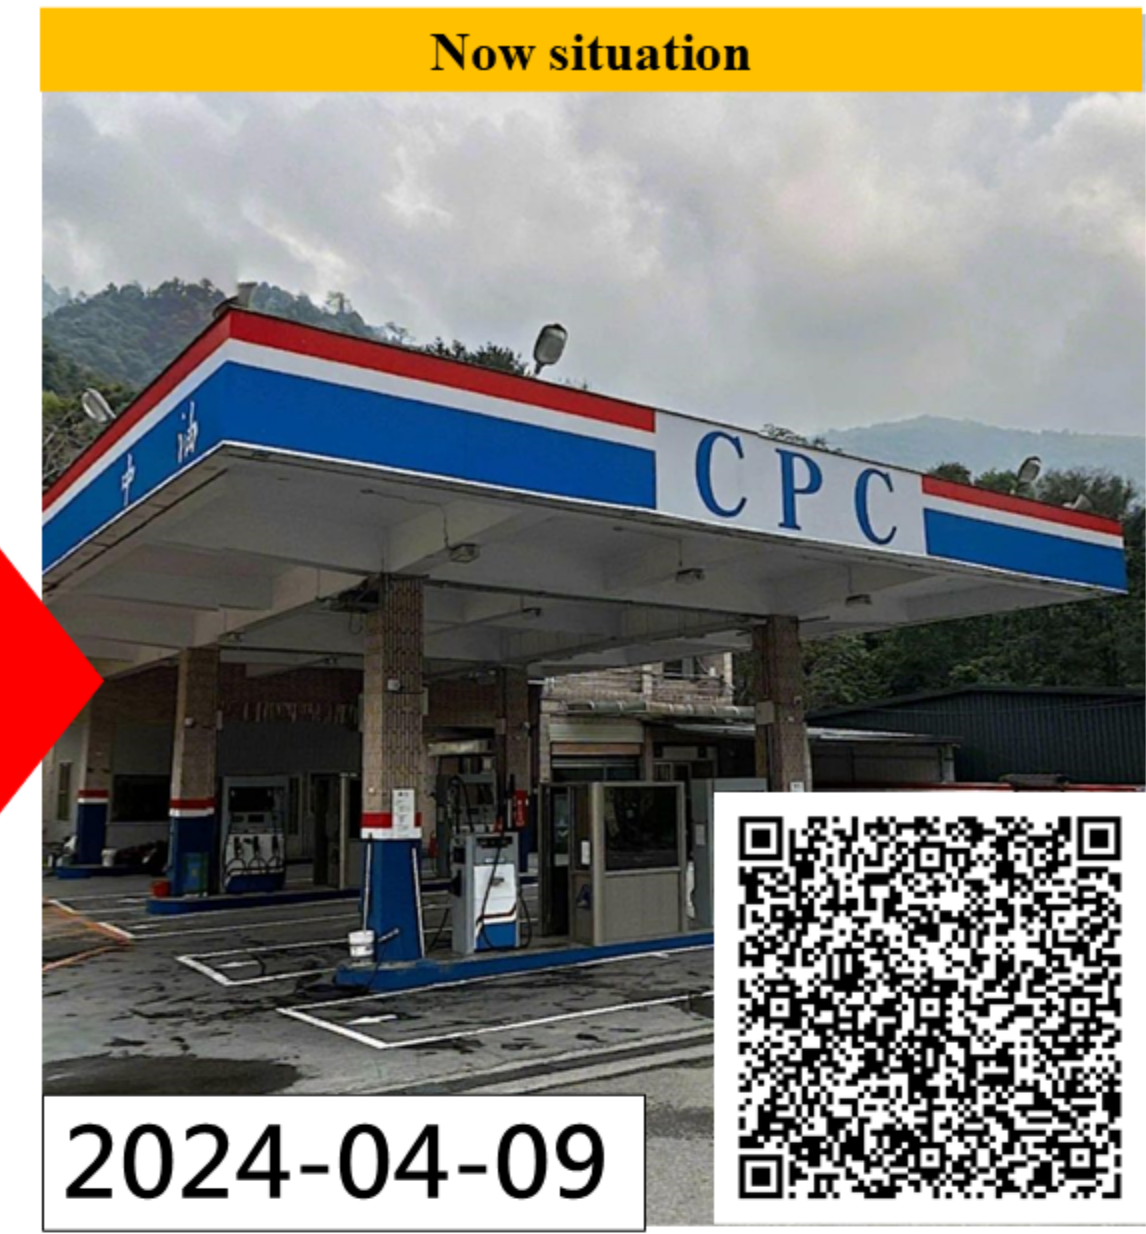
2024-04-09  
Now situation
