## 河道凸岸地形對土石流運移影響以花縣 DF024 為例

## The Influence of the Convex Bank on Debris Flow Movement

2024 中華水土保持研討會

# 河道凸岸地形對土石流運移影響 以花縣DF024為例

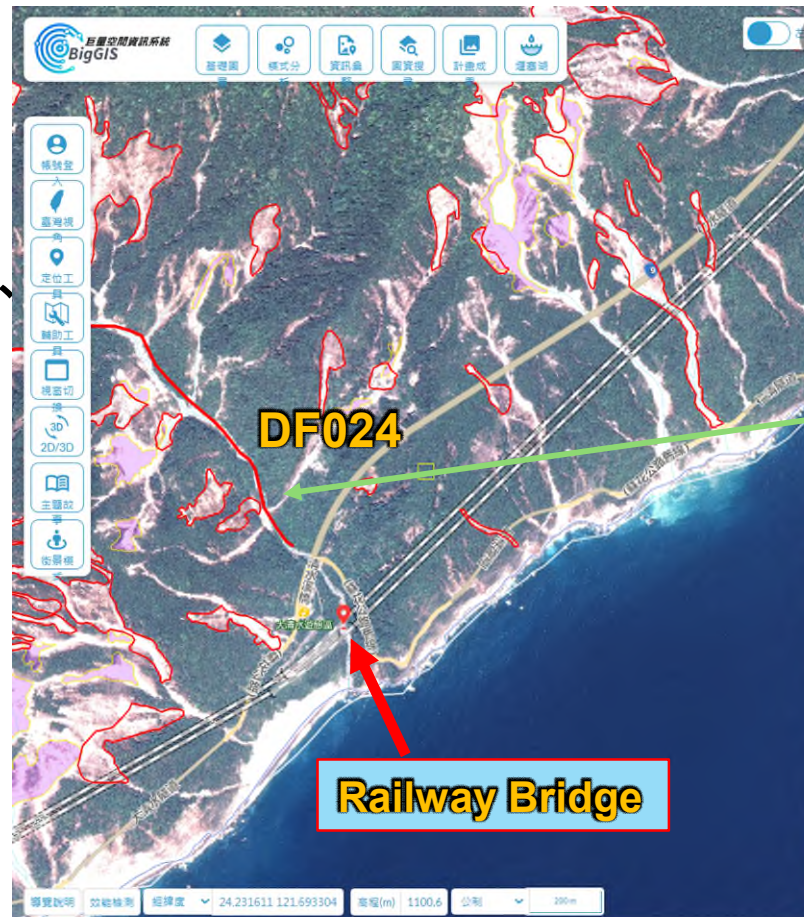
## Landslide Identification

- **Hualien County** (HSIU-LIN、WAN-RONG、FENG-PIN、SHOU-FENG、CHI-AN);
- **Yilan County** (NAN-AO、TA-TUNG、SU-AO);
- **Nantou County** (JEN-AI);
- **Taichung City** (HE-PING)
- **1,942** New Landslides
- **Landslide Area: 1521.03 ha**

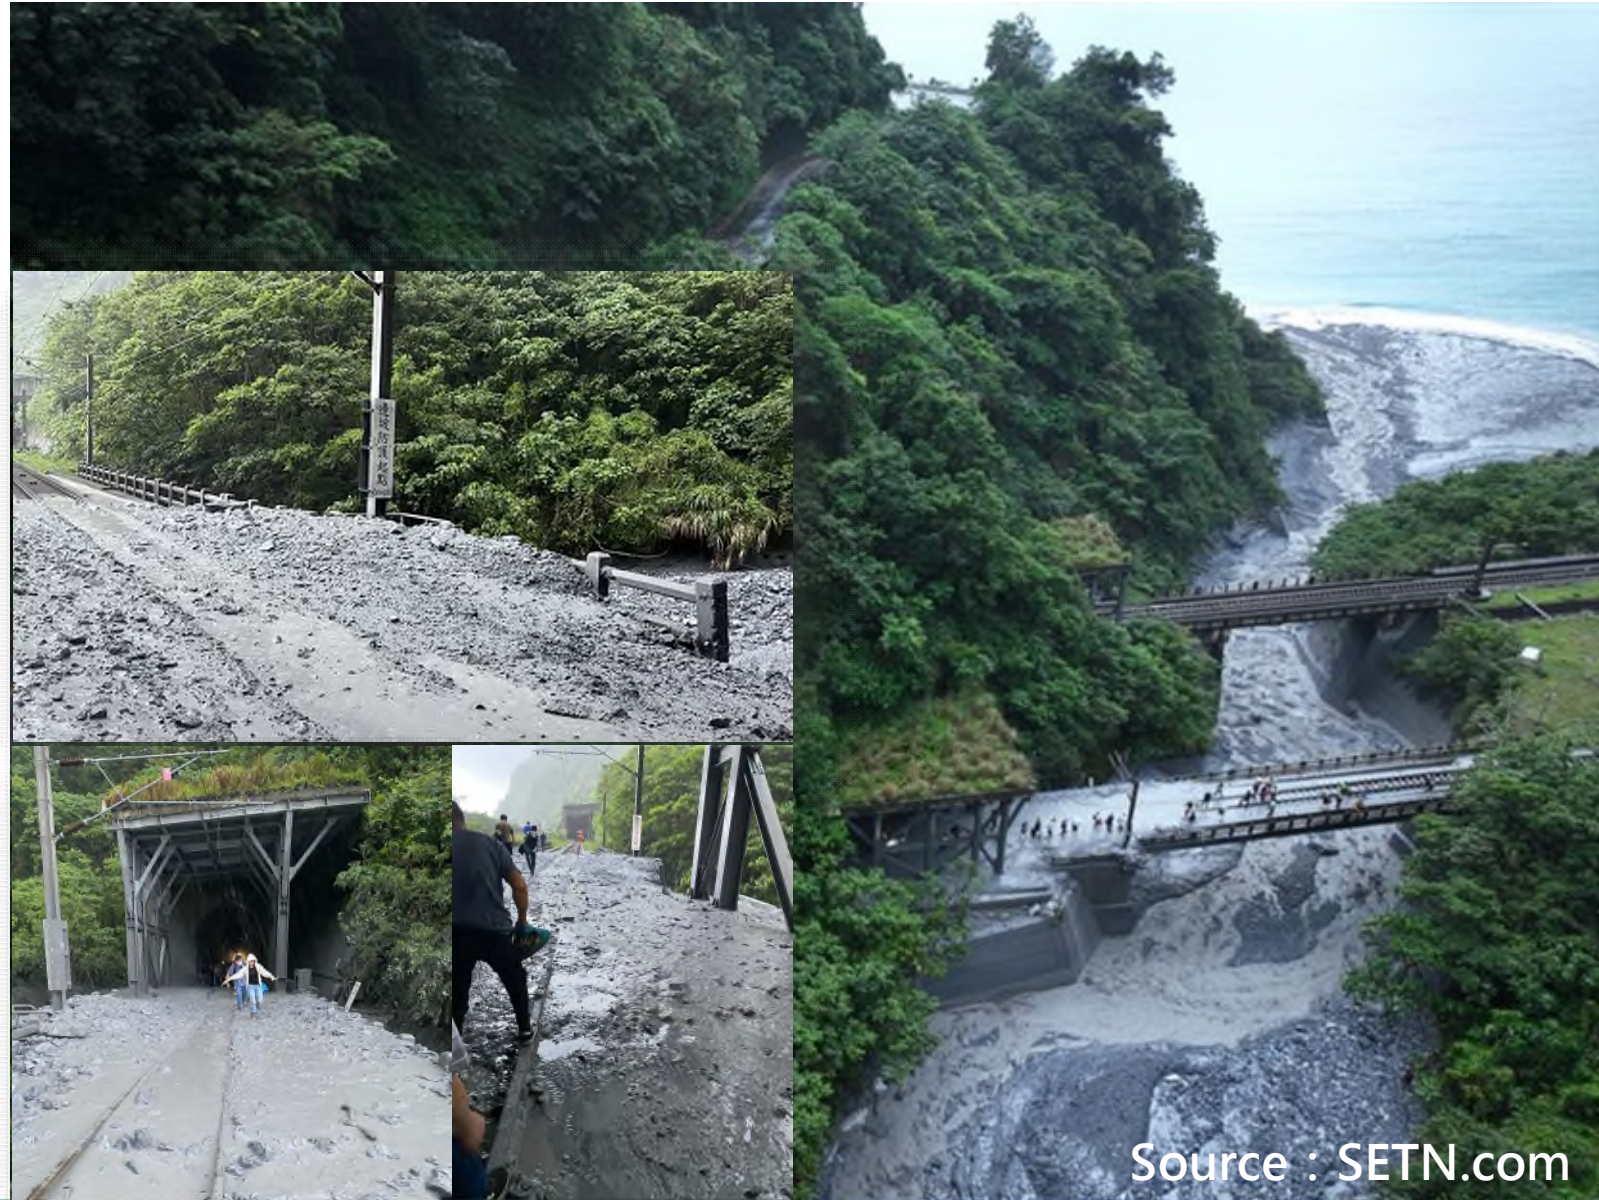
- Taiwan Express Train Derailment
- Debris Flow outburst:
  - 2024/06/21 16:30
- Train Derailment
  - 2024/06/21 16:50
- Location: The Hualien Daqingshuishi Creek
- Casualty: 9 People Injured and train damage

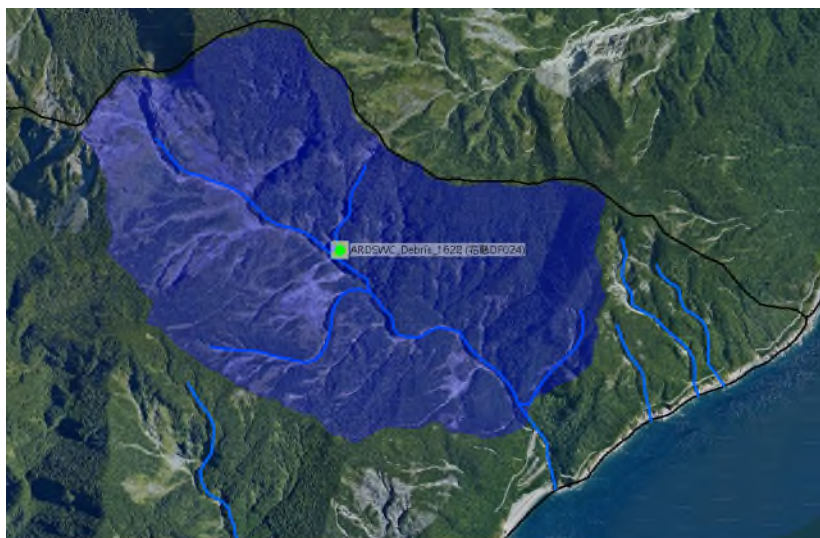
Based on rainfall data and Wflow rainfall runoff model, the **maximum rainfall was 28.5 mm** on June 20, and estimated **river flow was 10.24 cms.**

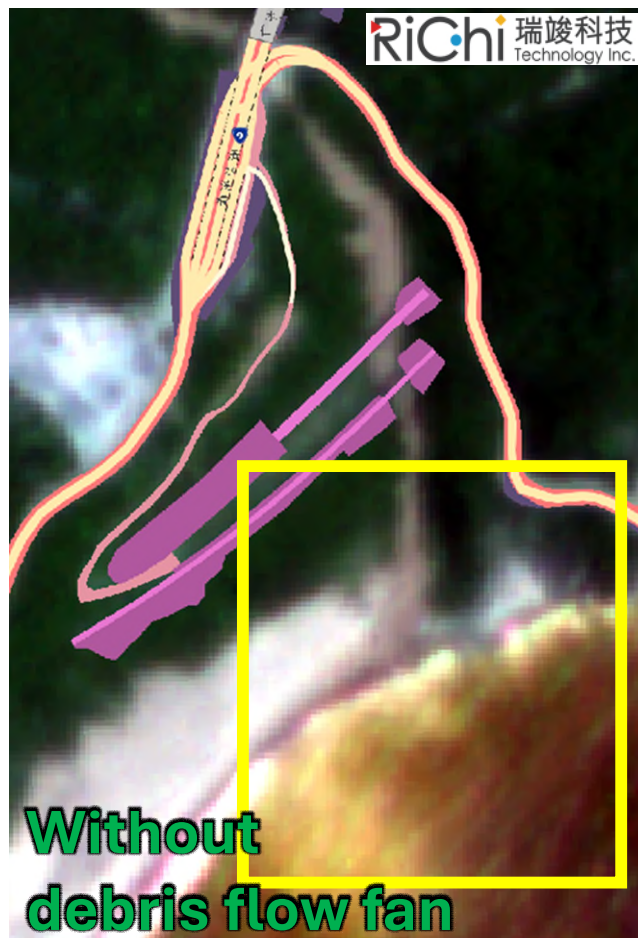
2024/06/20 10:37 Planet

- ✓ The 1<sup>st</sup> wave of debris flow occurred on June 20 at 17:00~20:00 ;
- ✓ The 2<sup>nd</sup> wave of debris flow occurred on June 21 at 16:30

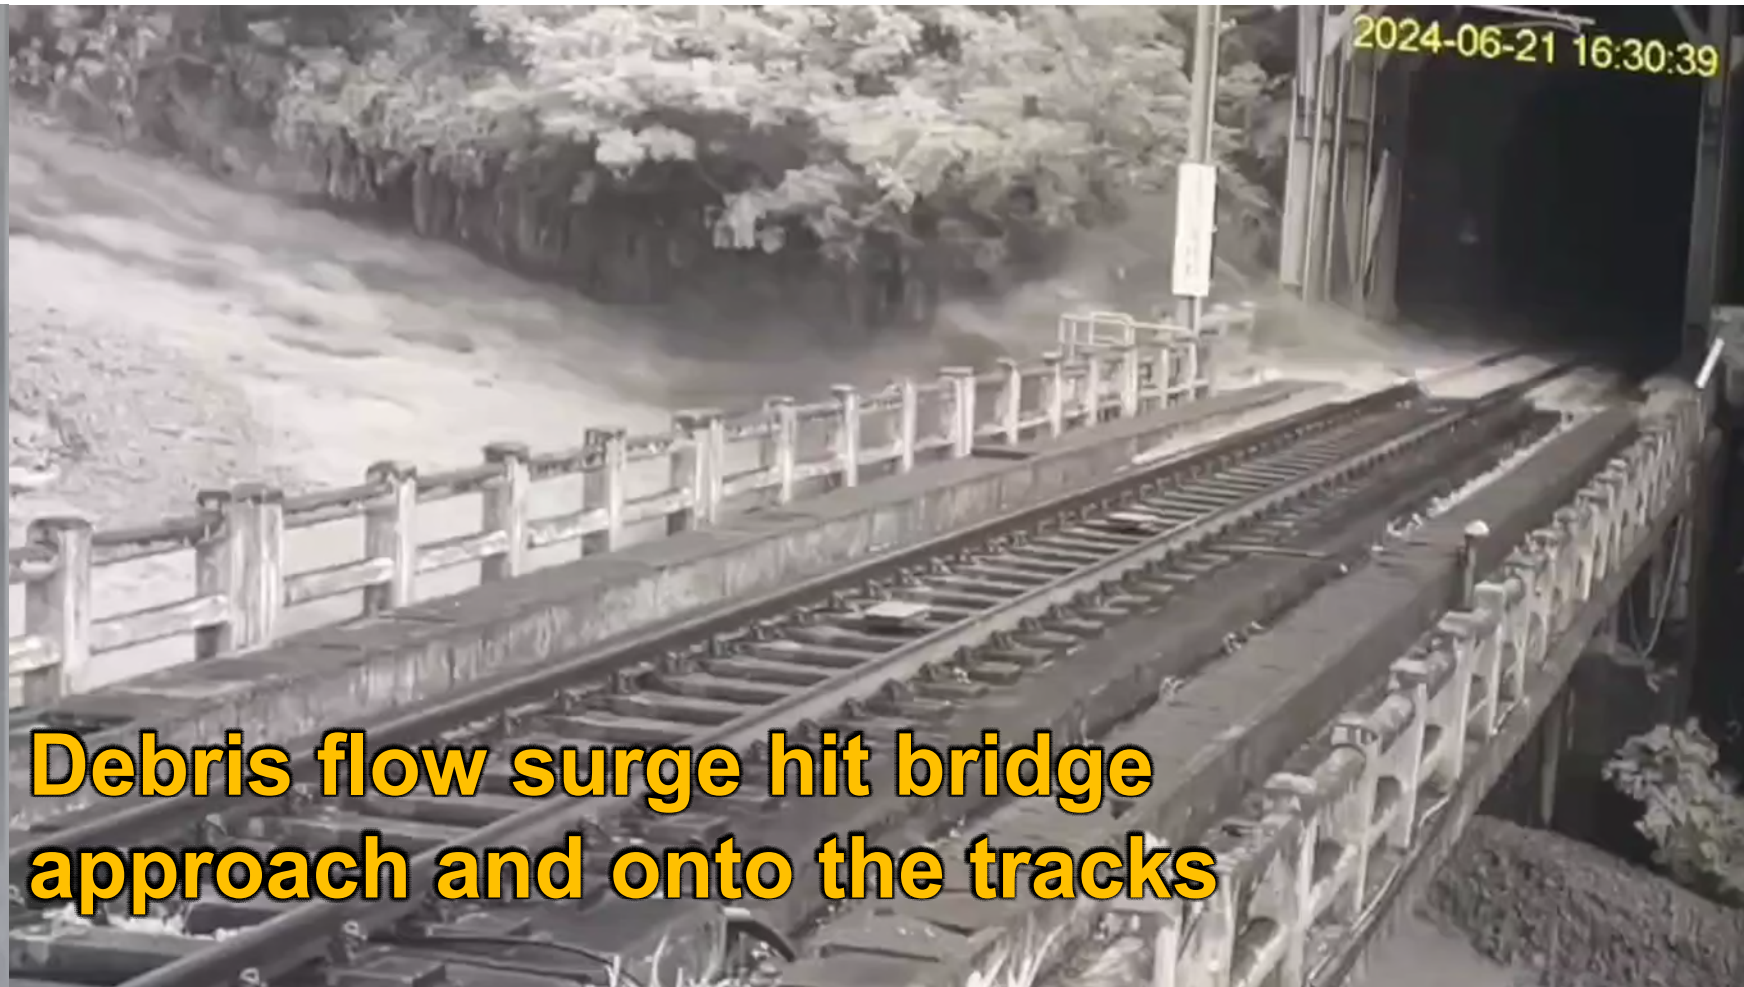
**Debris flow surge hit bridge approach and onto the tracks**
