# 河道凸岸地形對土石流運移影響 以花縣DF024為例

農村發展及水土保持署  
減災監測組 林駿恩

113年3月18日

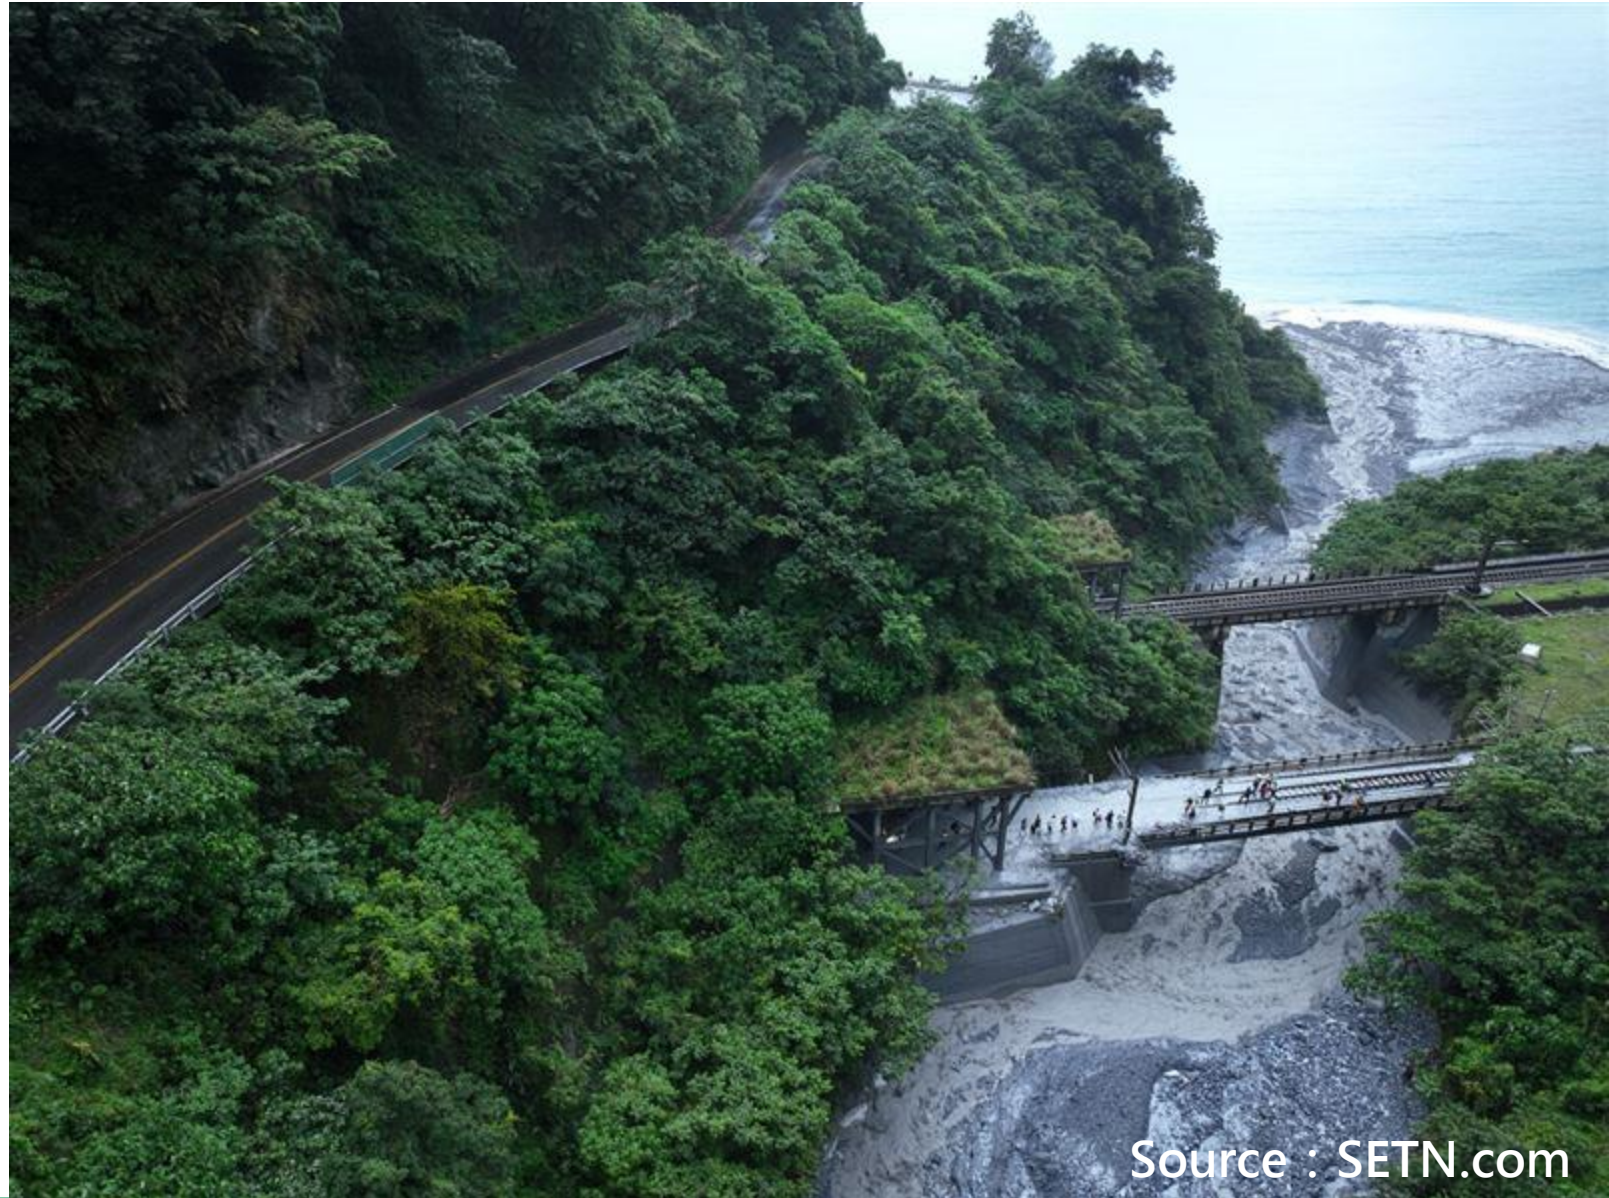
- Taiwan Express Train Derailment
- Debris Flow outburst:
  - 2024/06/21 16:30
- Train Derailment
  - 2024/06/21 16:50
- Location: The Hualien Daqingshuishi Creek
- Casualty: 9 People Injured and train damage

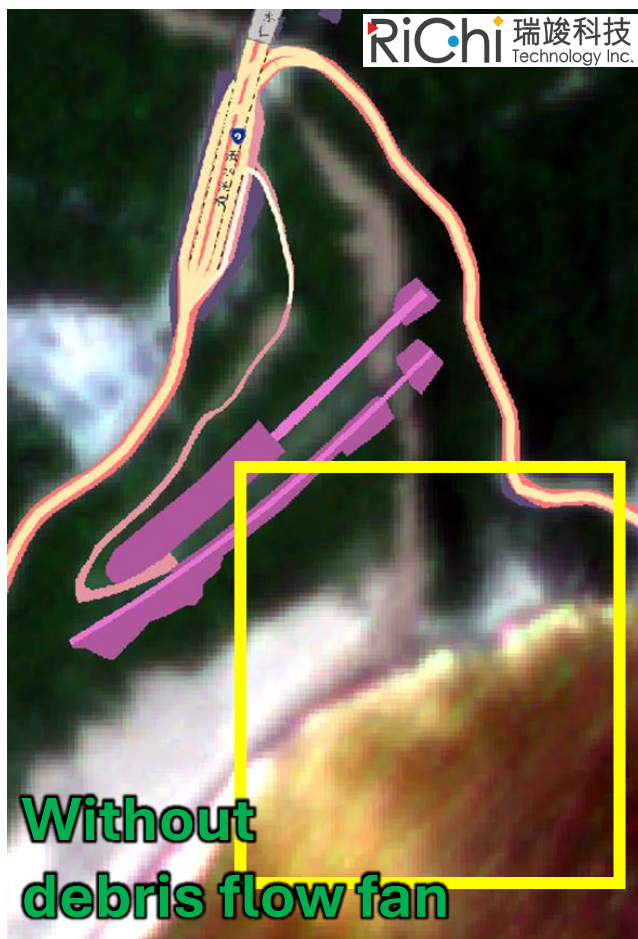
2024/06/20 10:37 Planet

- ✓ The **riverbed was lifted** by a debris flow occurred on **June 20 at 17:00~20:00** ;
- ✓ The **debris flow surged onto the railway tracks** on **June 21 at 16:30**

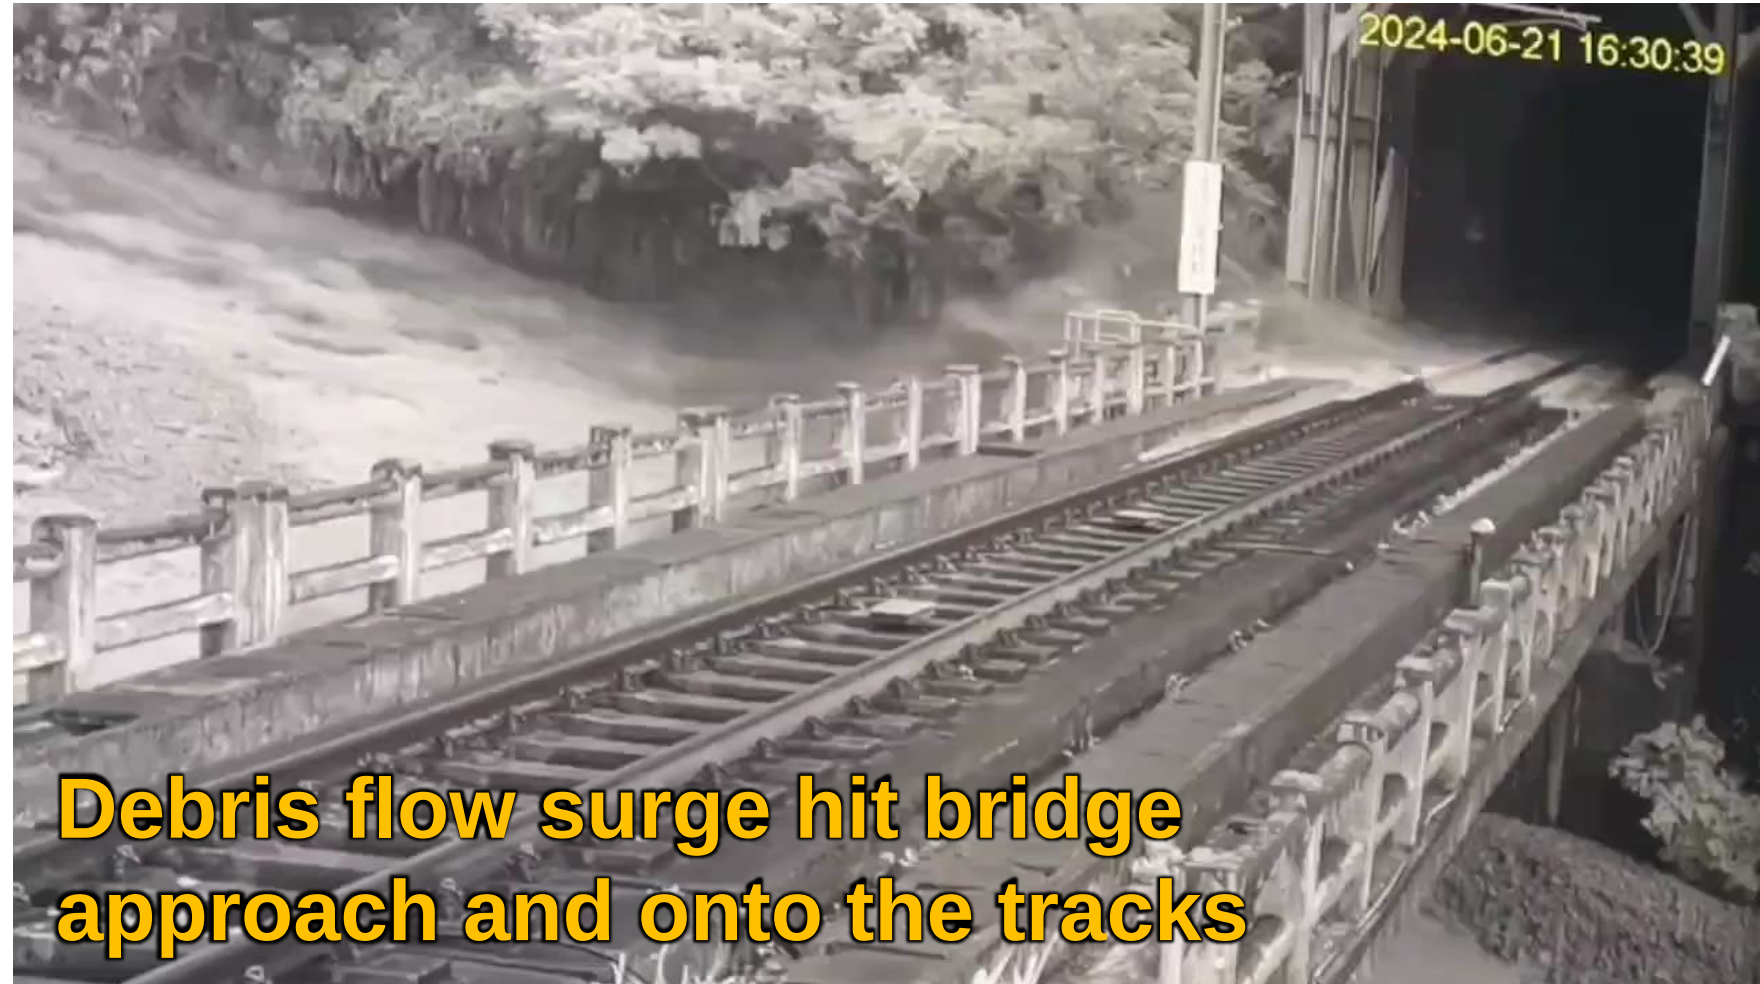
# Debris Flow Event

Debris Flow outburst: 2024/06/21 **16:30**  
Train Derailment: 2024/06/21 **16:50**

- ✓ Debris flow surge hit bridge approach.
- ✓ Debris splash onto the railway tracks.
- ✓ Debris flow affected the railway on June 21 at 16:30.
- ✓ Taiwan Railway Express Train derailed on June 21 at 16:50.
- ✓ There was a **20-minute loss** in warning time.
